#### NASA/TM-1999-209097 ARL-MR-439

# Testing and Analysis of Composite Skin/Stringer Debonding Under Multi-Axial Loading

Ronald Krueger and Michael K. Cvitkovich Langley Research Center, Hampton, Virginia

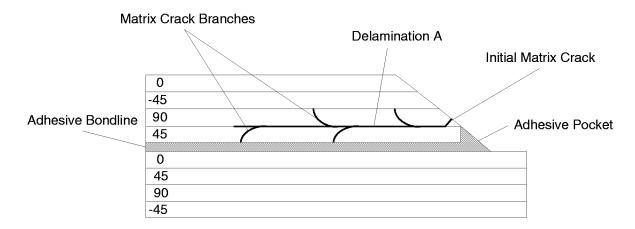
(a) Corners 1 and 4

At corners 1 and 4, a delamination running in the 90°/45° flange ply interface (delamination A) initiated from a matrix crack in the 90° flange ply as shown in Figure 13(a). At longer delamination lengths, new matrix cracks formed and branched into both the lower 45° as well as the upper 90° flange ply. However, no branching into the adhesive bondline was observed.

Figure 13. Typical Damage Patterns.

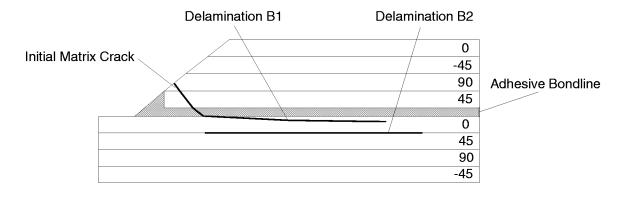
(b) Corners 2 and 3

At corners 2 and 3 a matrix crack formed at the flange tip in the  $90^{\circ}$  flange ply that subsequently ran through the lower  $45^{\circ}$  flange ply and the bondline into the skin. Subsequently, a split (delamination B1) formed from the tip of that matrix crack within the top  $0^{\circ}$  skin ply as depicted in Figure 13(b). In some cases, a second delamination (delamination B2) was observed below the first in the top  $0^{\circ}/45^{\circ}$  skin ply interface. Both delaminations were present over a long distance until delamination B1 stopped and delamination B2 continued.

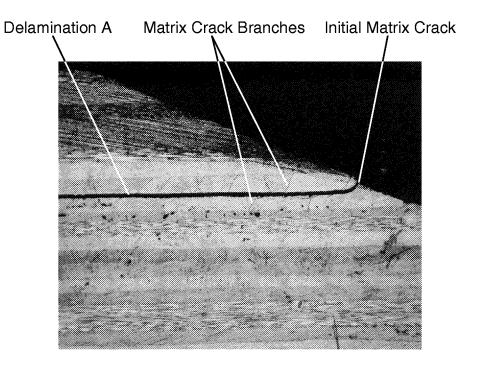
(a) Delamination A in the  $90^{\circ}/45^{\circ}$  Flange Ply Interface at Corner 4

Figure 14. Micrograph Showing the Side View of a Failed Three-Point Bending Specimen.

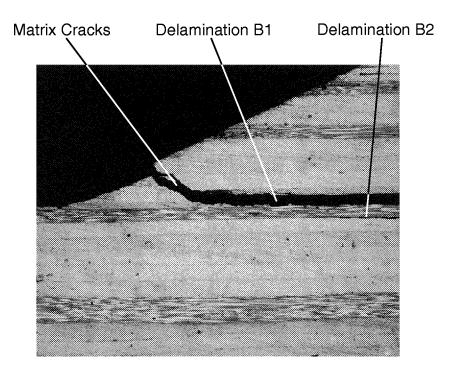
The above findings suggest that once a matrix crack has formed, a delamination (delamination B1 from Figure 14) will also form and grow in an unstable manner between the adhesive film and the top  $0^{\circ}$  skin ply. The second delamination observed in the  $90^{\circ}/45^{\circ}$  flange ply interface (delamination A from Figure 14) requires more energy to initiate than available at the load levels used in this FE analysis, i.e., the loads corresponding to possible matrix ply crack initiation. The energy for this second delamination may come from an increase in load or may be caused by an increase in  $G_{\rm T}$  due to the presence of the first delamination in the  $0^{\circ}$  skin ply/adhesive film interface. These two possibilities are studied in detail in the following paragraphs. The response of the numerical model with respect to the difference in axial moduli measured in tension and bending is discussed in the appendix at the end of the paper. This discussion includes the effect of a lowered axial modulus on computed strain energy release rates for specimens subjected to bending and combined tension/bending loading.

(b) Delamination B1 in the Top 0° Skin Ply and Beginning of Delamination B2 in The top 0°/45° Skin Ply Interface at Corner 2
